Bridgehead Pipeline Replacement Project Authorization

Board of Directors Meeting
September 9, 2020

Bridgehead Pipeline Failure Event Summary

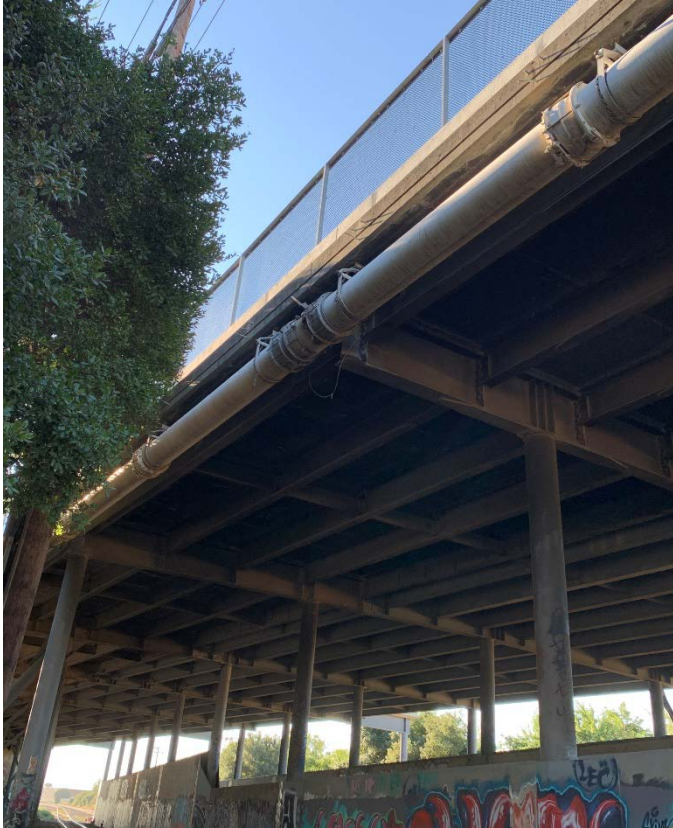
18-inch pipeline suspended on north side of Wilber Ave. bridge (ductile iron pipe with polyethylene liner);
2.4 million gallons per day of flow

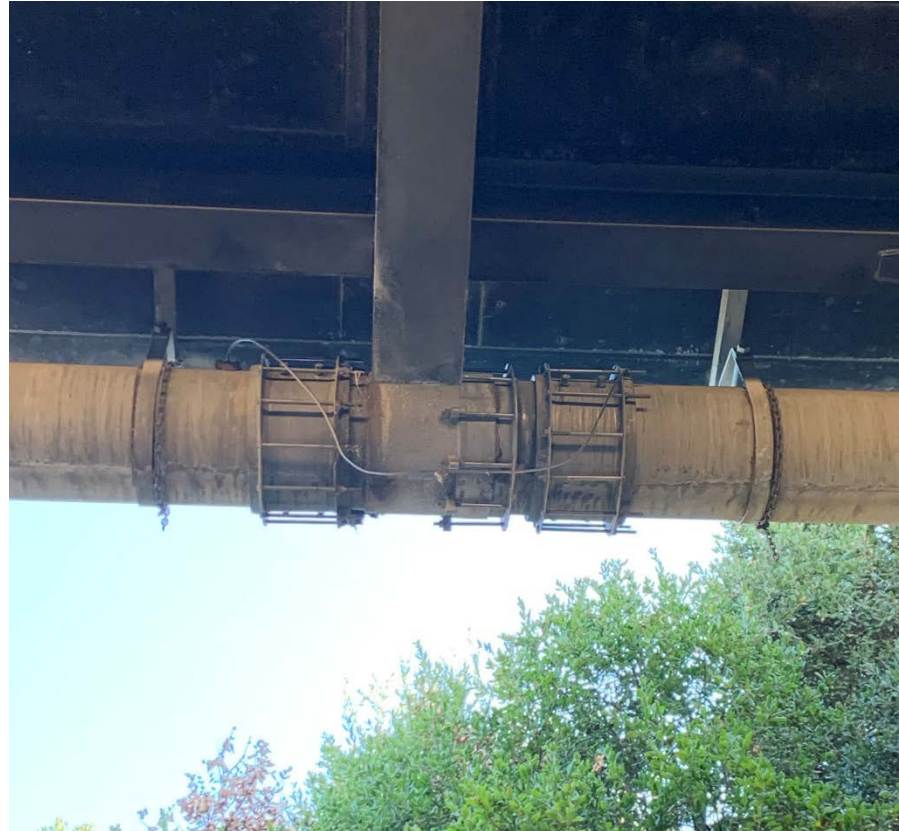
6-foot expansion coupling joint with
cathodic protection jumper wire
(unlined stainless steel)

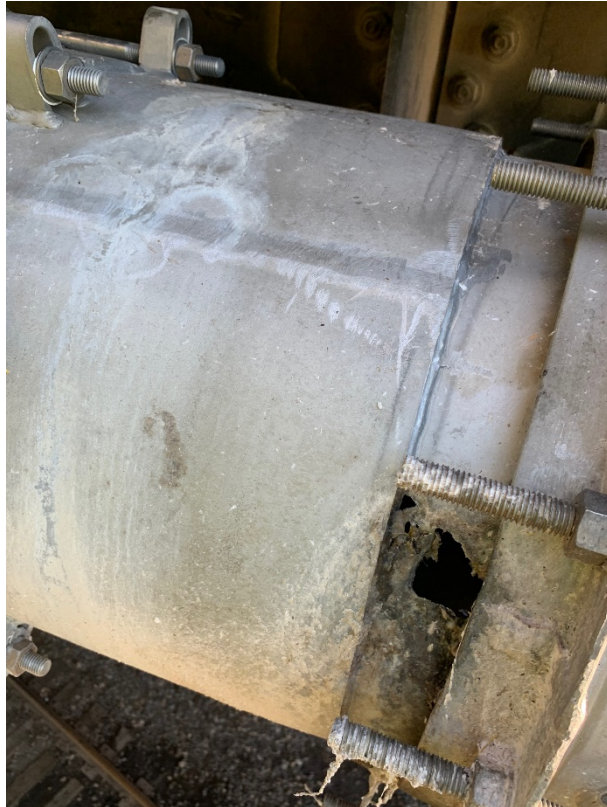
Corrosion failure at
flowline of expansion joint

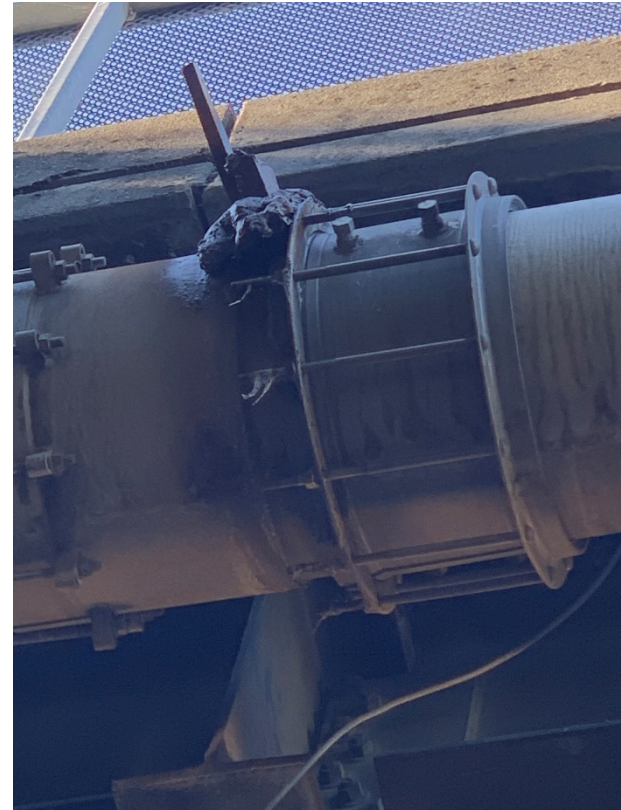
Initial temporary repair
at expansion joint

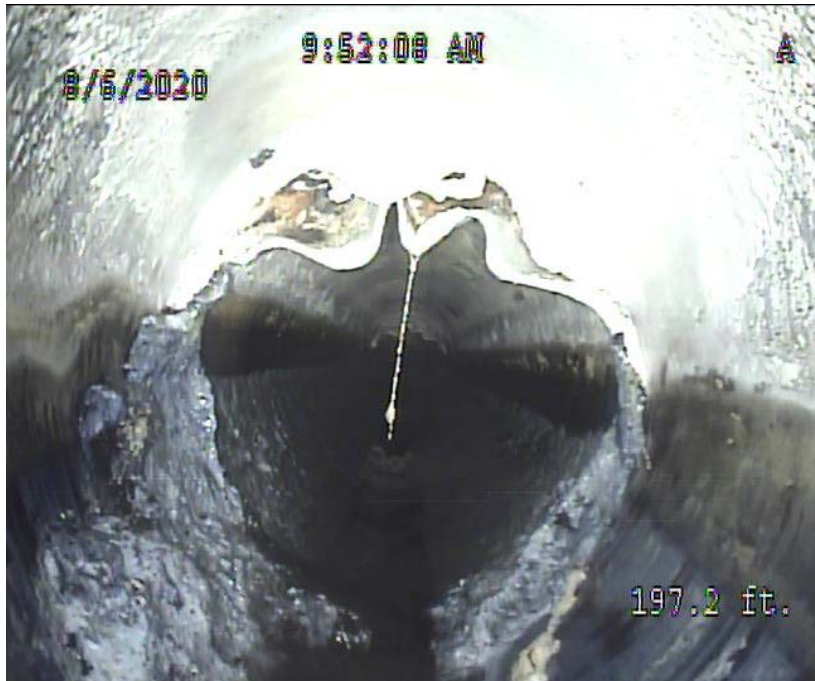
PE liner delamination at pipe joint
(restricts flow capacity)

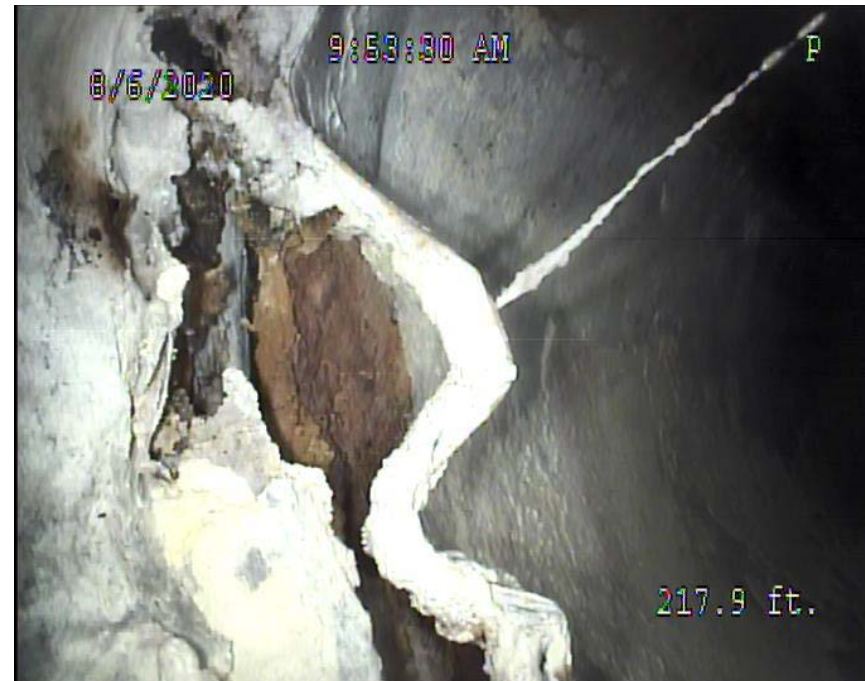
Ductile iron pipe corrosion at
PE liner failure

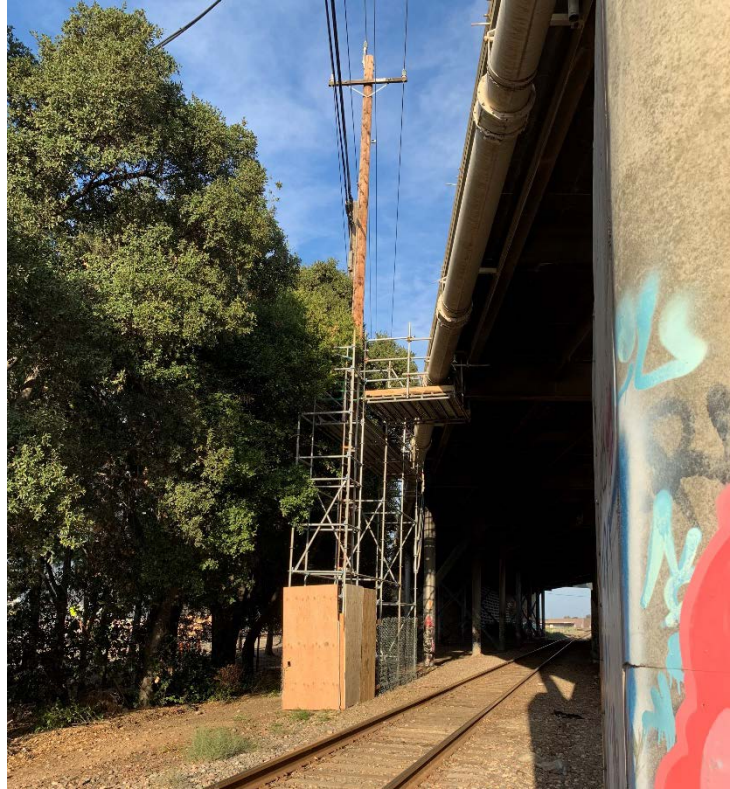
Scaffolding to access pipeline
and allow train movement

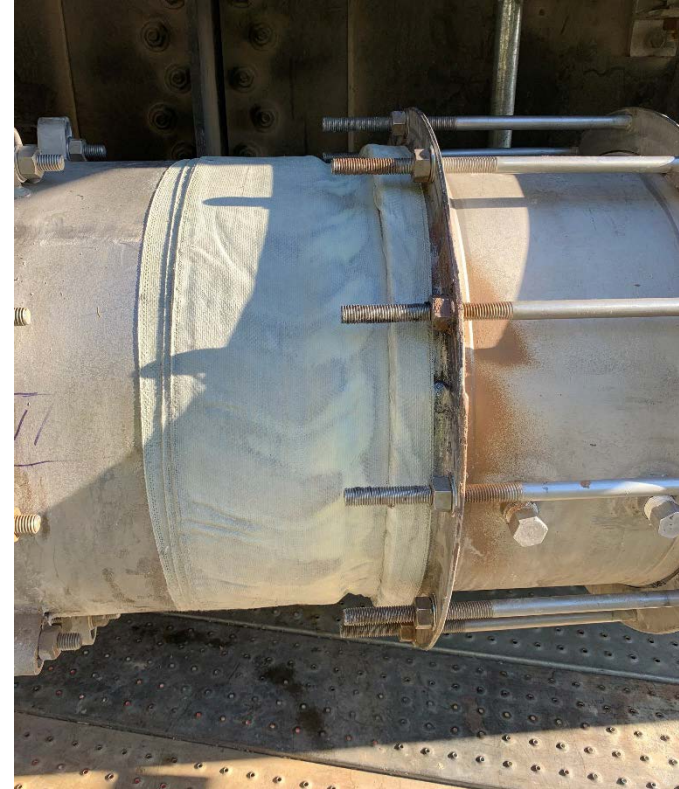
Improved temporary repairs
